14-1 INTRODUCTION

Tappan Zee Hudson River Crossing Project Environmental Impact Statement

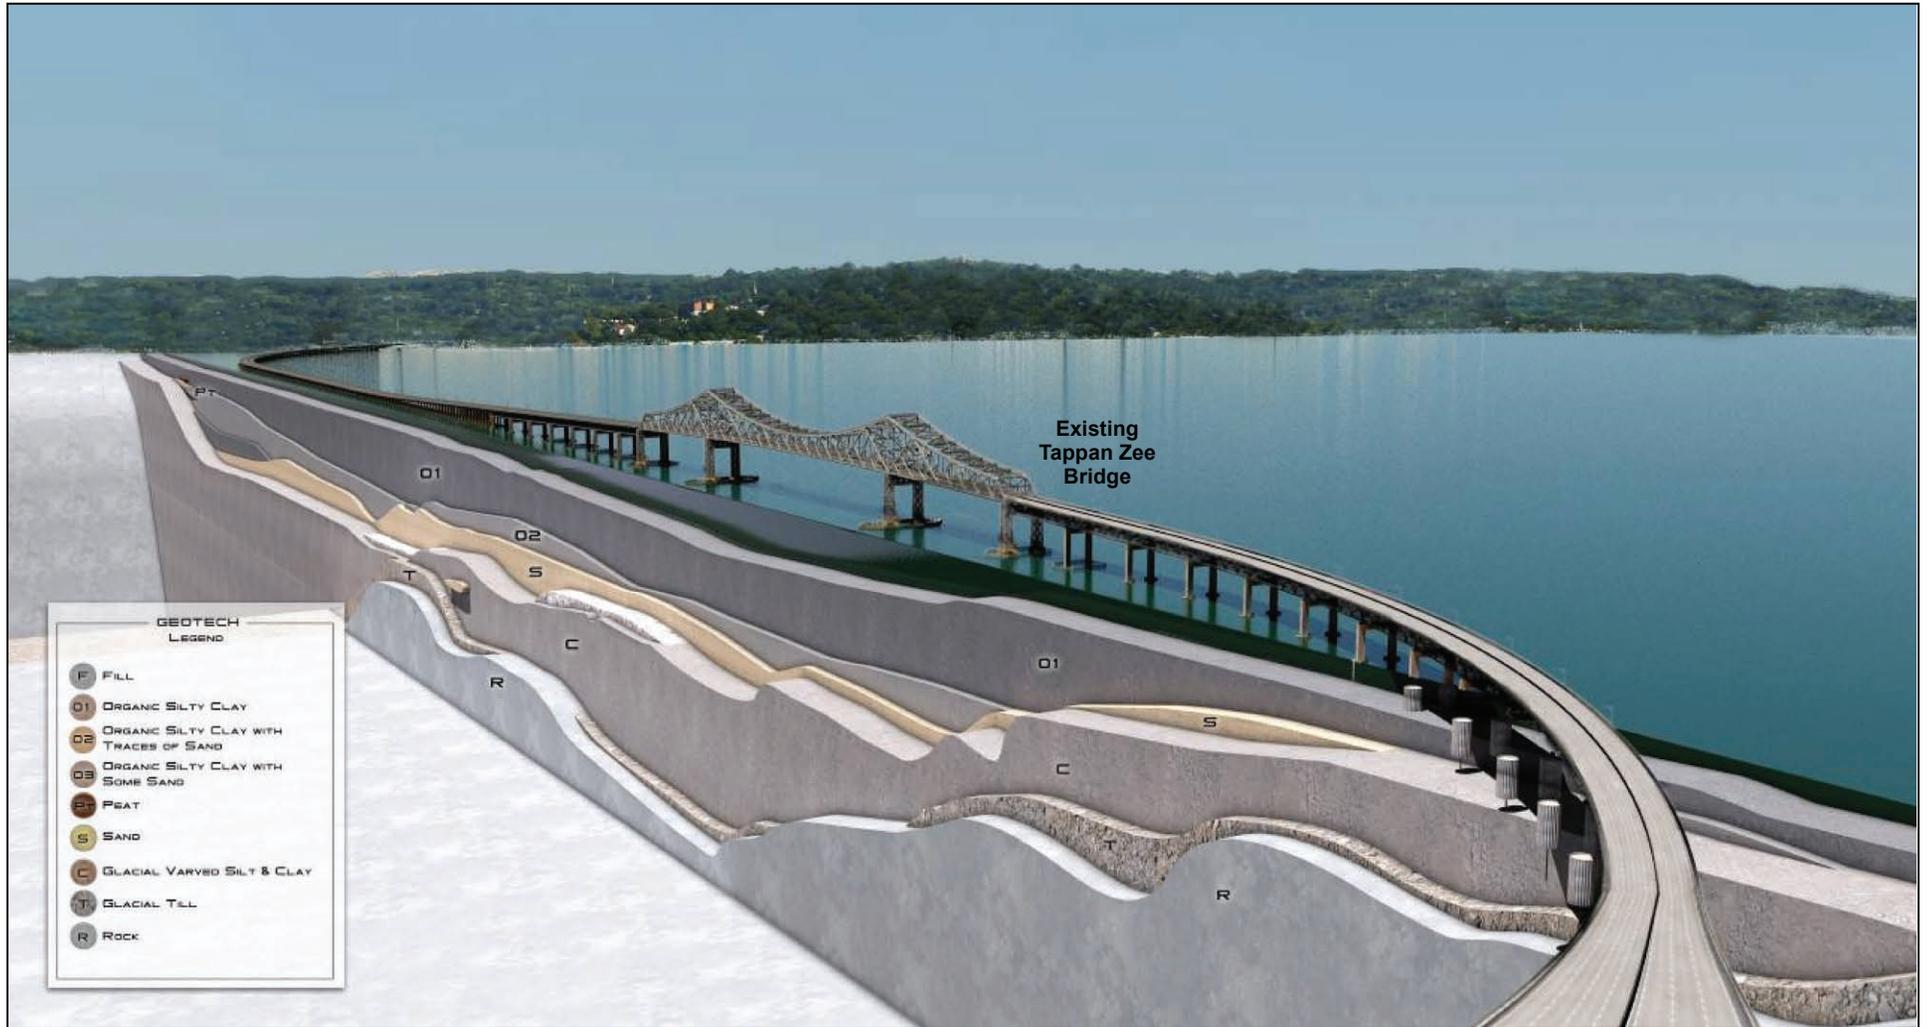
The Brunswick formation extends under the western portion of the Hudson River. Near the western shoreline, bedrock is located at approximately 60 feet below mean sea level (MSL) but drops abruptly to more than 700 feet below MSL (Worzel and Drake, 1959) due to a pre-glacial river channel. Near the middle of the Hudson River, bedrock is located between 220 and 270 feet below MSL. **Figure 14-4** provides a cross-section of the Hudson River’s geological characteristics.

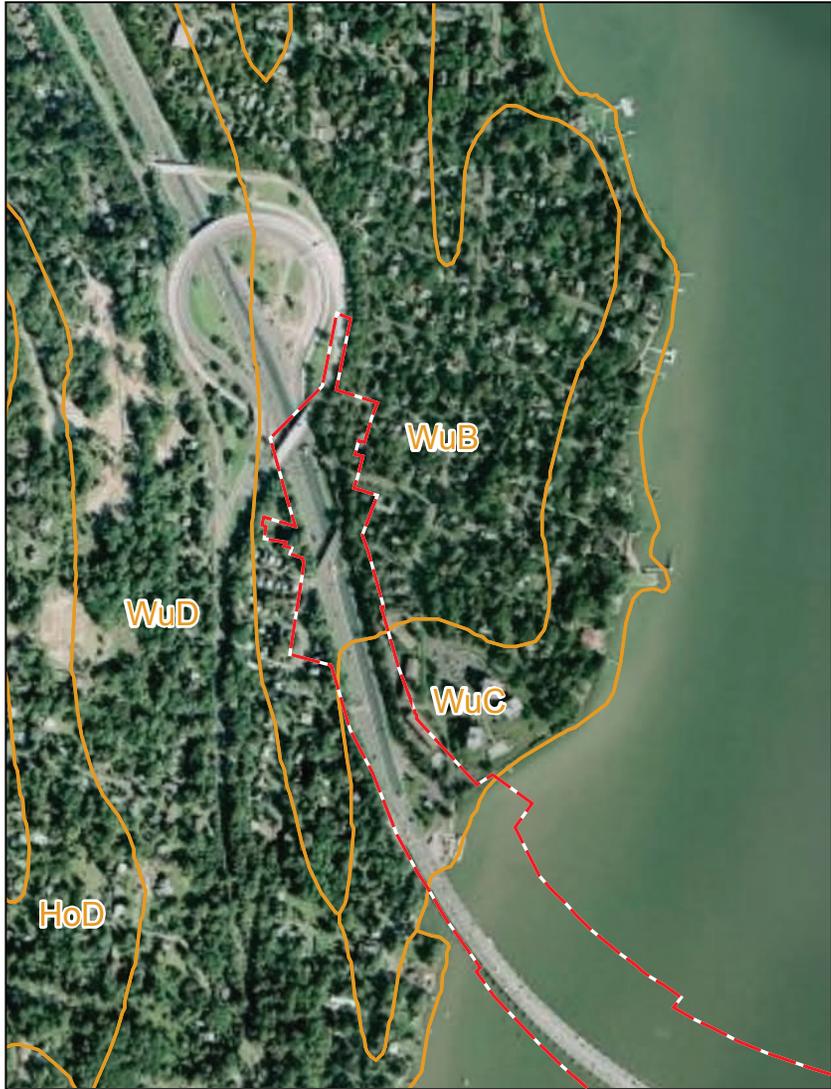
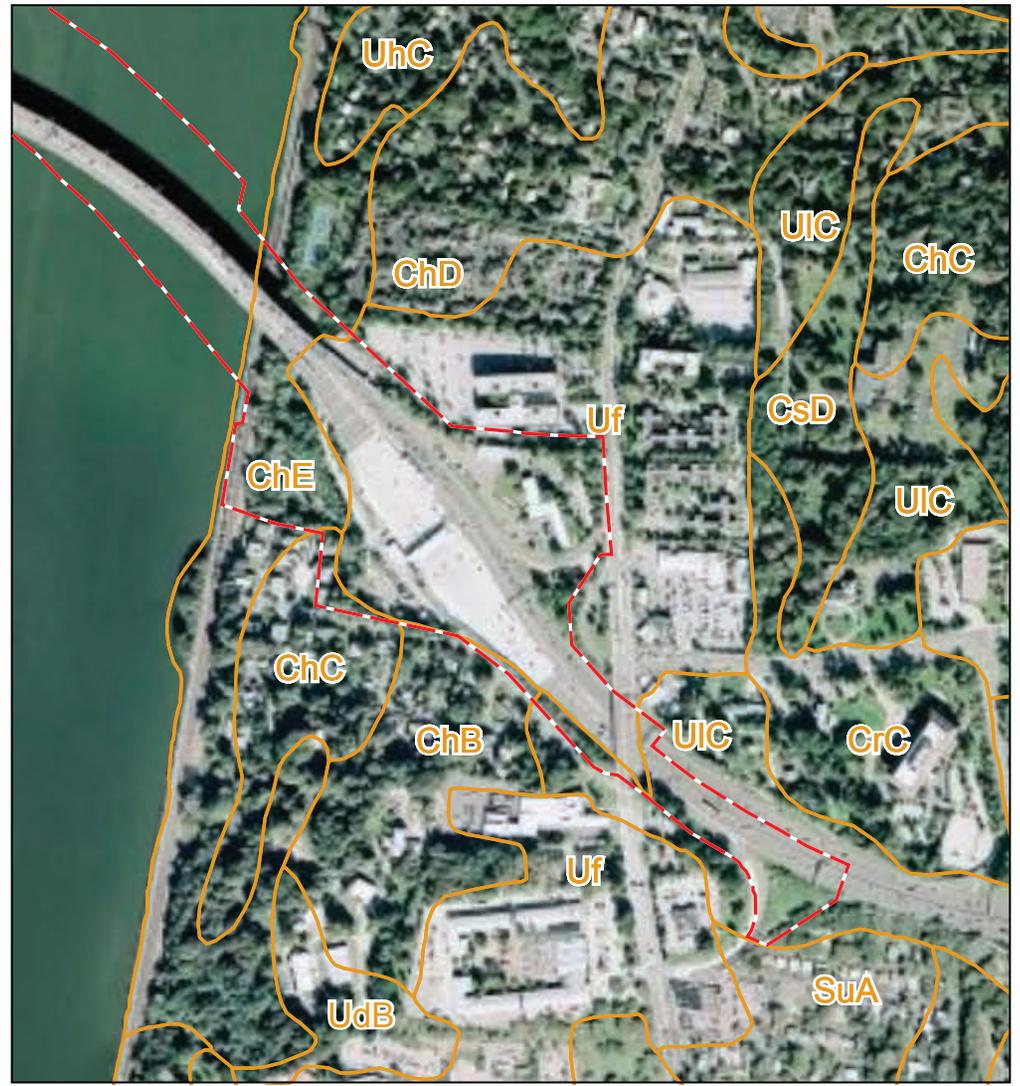
Table 14-1 contains a complete list of the soil mapping units located within the study area and lists their primary characteristics. The spatial arrangement of these soil types, as mapped by the NRCS Soils Survey of Rockland County (1990) and the Soil Survey of Putnam and Westchester Counties (1994), is shown on **Figure 14-6**.

The primary concerns related to soils are erosion and suitability for construction. Erosion characteristics for the soils in the study area range from moderate to very severe. The main limitations for construction of roadways are slopes, variable depth to

bedrock, and frost action, all of which are common for this region. Grading, erosion and sediment control plans, and other engineering measures can and will be put in place to overcome these limitations.
